HEATGUARD 135 & 145

STRAINER/CHECK VALVE SERVICING GUIDE

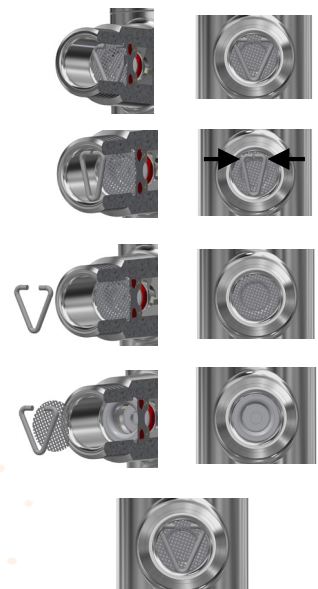
1. With the valve removed from the line, you will need to remove the triangular circlip that holds each strainer in.
2. Using a pick or needle nose pliers, move the longer two sides of the triangle towards the middle of the inlet, until they are disengaged from the groove.
3. Remove the circlip, leaving the strainer free.
4. Remove the strainer and rinse until debris is cleared. It is not necessary to remove the check valve.
5. Reinsert the strainer and circlip until the circlip snaps back into the groove. You may need to use a utensil to aid in this process.
6. Reinstall valve and return water supply.

If the strainer screen is still clogged after attempting Step 2 above, it may be required to remove the strainer from the valve. If necessary, please follow the steps below.
